Mission Accomplished, Nebagamon Creek

By Paul Piszczek, Wisconsin DNR Fisheries Biologist Dennis Pratt, Brule River Sportsmen's Club President, and retired Wisconsin DNR Fisheries Biologist

Mission Accomplished, the South Shore Rail Grade on Nebagamon Creek is gone.

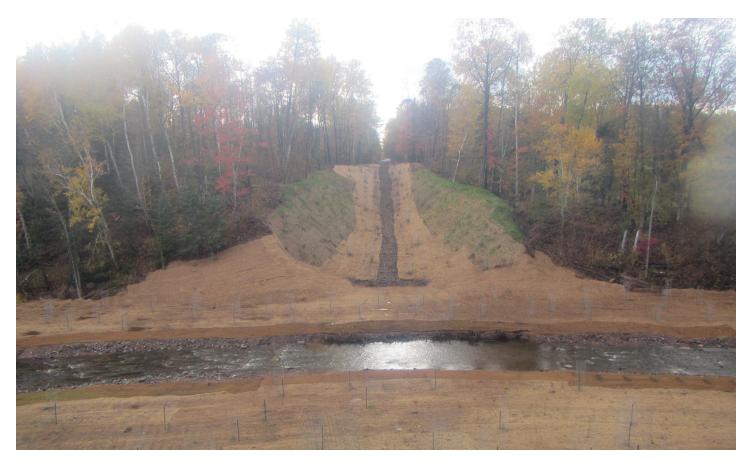
Nebagamon Creek facing west. Photos courtesy Paul Piszczek

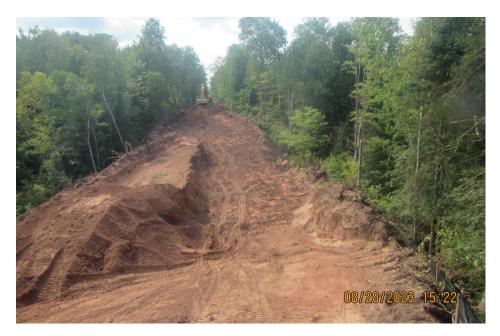
Railroad grade facing west.

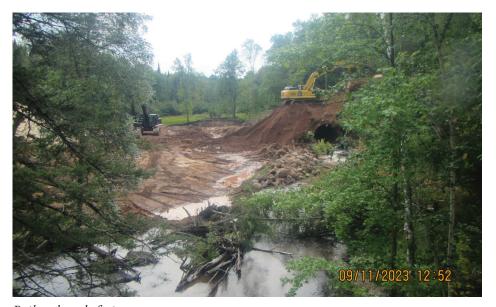
Photo 1: Railroad grade facing up stream.

Railroad grade facing up stream.

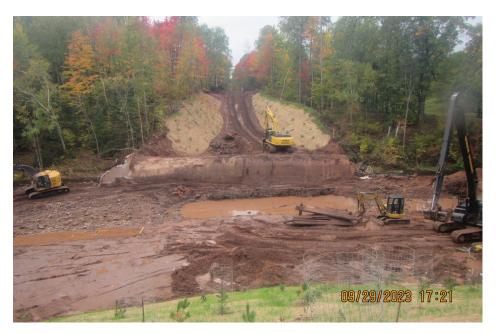
Railroad grade facing west.

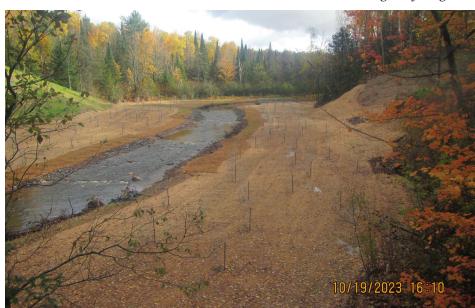
Railroad grade facing up stream.
